STERN DRIVES/INBOARD ENGINES

service bulletin

NUMBER: 79-9

- A. Rochester Quadrajet Carburetor Idle Mixture Screw
- B. MCM 470 Voltage Regulator
- C. MCM 470 Dual Station Water Temperature Sender
- D. V-8 Engine Timing Chain/Sprocket Replacement

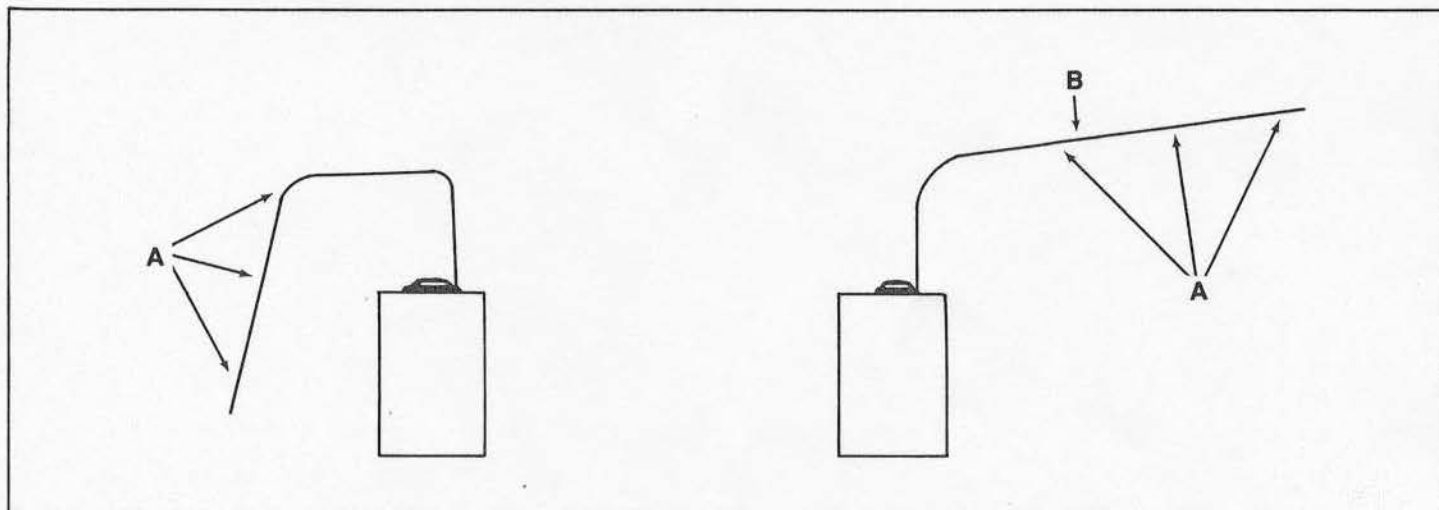
a - Mounting Holes in Copper Strap
b - Location to Cut Off Copper Strap

Condenser B-392-6324 (Figure 1) is used in Prestolite distributors on MCM 888, MCM 233 and MIE 233. The condenser has a copper strap with 3 mounting holes. When installing a replacement condenser, it is necessary to bend the strap in the opposite direction (180°) and to cut the strap off at the hole next to the condenser. (Figure 2) If this procedure is not followed, the copper strap will short out to the distributor housing.

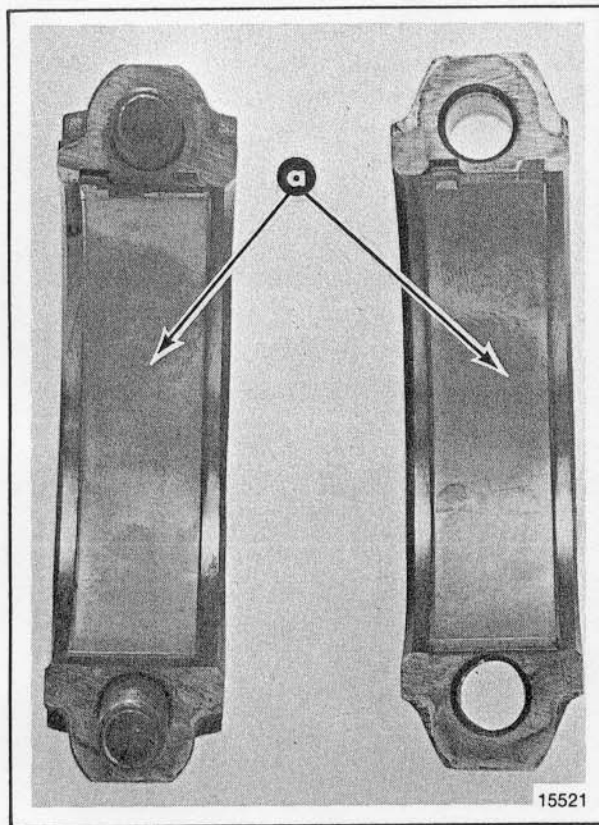
Figure 1. Correct Bearing Installation

During the installation of connecting rod bearings into the connecting rods, make sure bearing halves are installed correctly. Improper installation of these bearings can cause premature failures.

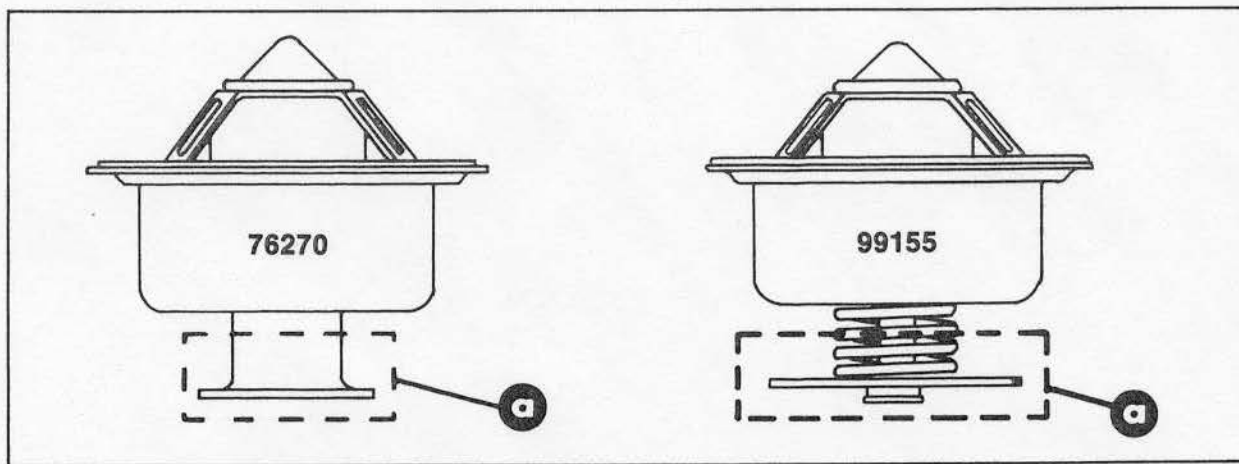
a - Umbrella Must Be On Thermostat

NOTE 8: Automotive thermostats CANNOT BE USED in these engines because they DO NOT direct the coolant flow to the heat exchanger when thermostat is open. (Figure 1)

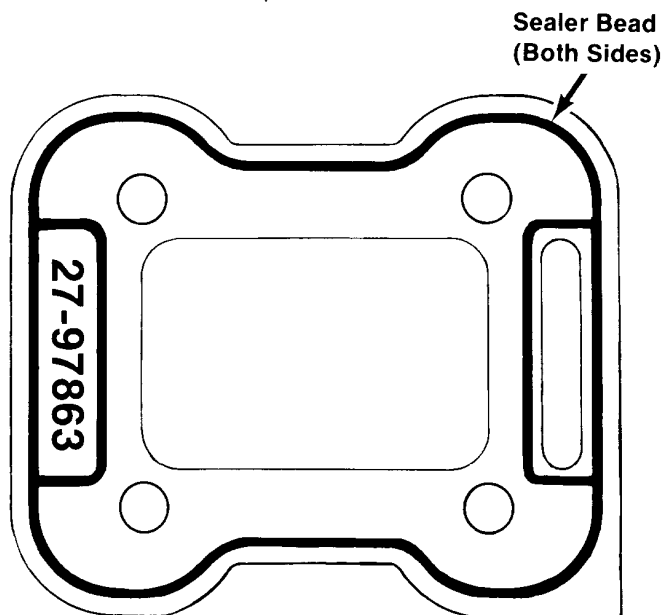
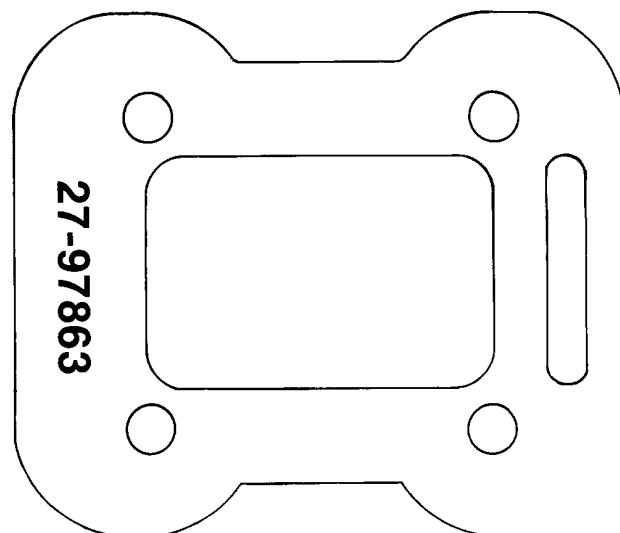
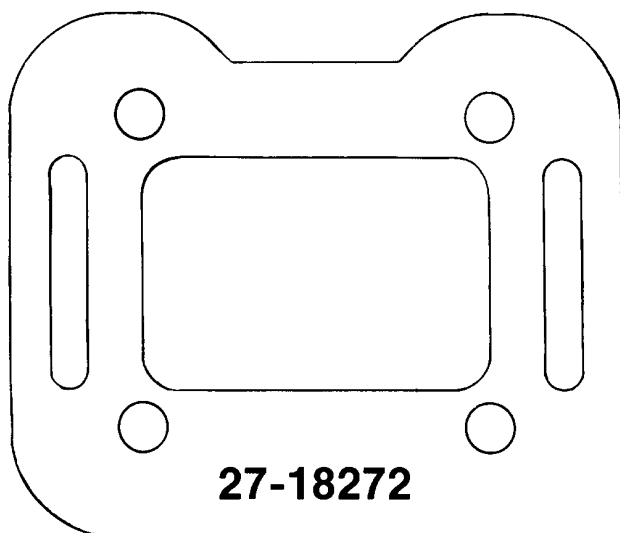
Figure 1.

There has been a few reports on the MerCruiser 224 CID 3.7 litre engines with aluminum exhaust manifolds having a piston knock caused by a tight piston pin. The starting serial numbers of engines with aluminum exhaust manifolds are 165/170 3.7L A528109 and up, 180/190 3.7 L/LX A528516 and up. The tight pin may be caused by engine coolant entering the cylinders because of a leaking exhaust elbow/reservoir to exhaust manifold gasket part number 27-97863. The early style 27-97863 gasket had a silicon seal on both sides. The later style 27-97863 gasket was changed to a graphite type (Figure 1). 27-97863 is now superseded to 27-18272 which is a graphoil/tin composite (Figure 1). Starting serial numbers of production engines, with the 27-18272 gaskets are 165 3.7L B742442 and up 180 3.7L/LX B743204 and up. Gasket part number 27-18272 is also in Quicksilver parts stock.

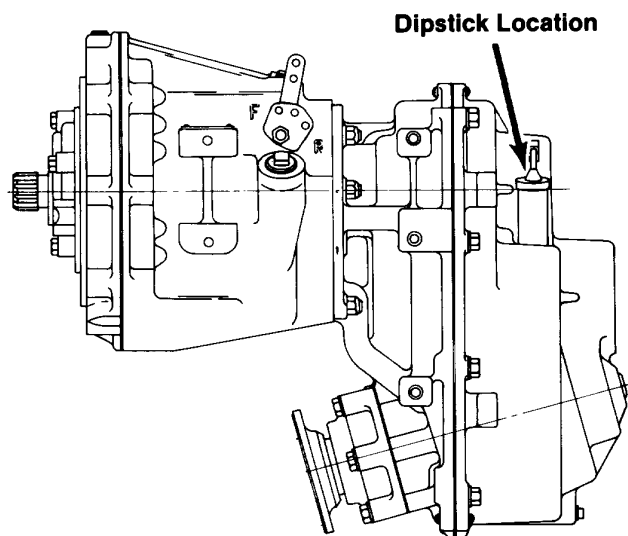
Figure 2.

Borg Warner V-Drive transmissions with dipstick located in V-Drive case (Figure 2) that have had intermediate shaft rear bearing failure should have oil capacity increased.
