STERN DRIVES/INBOARD ENGINES

service bulletin

NUMBER: 79-9

- A. Rochester Quadrajet Carburetor Idle Mixture Screw
- B. MCM 470 Voltage Regulator
- C. MCM 470 Dual Station Water Temperature Sender
- D. V-8 Engine Timing Chain/Sprocket Replacement

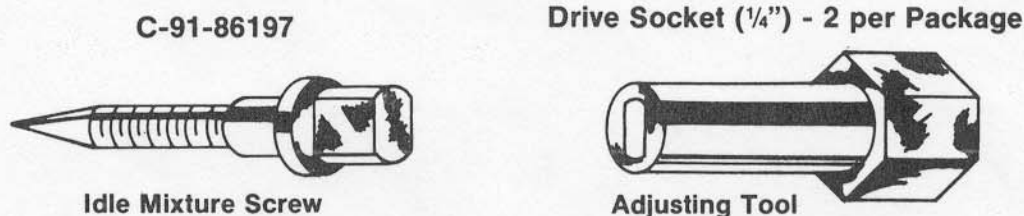
Figure 1. Idle Mixture Screw and Adjusting Tool

Rochester Quadrajet carburetors now incorporate a new style idle mixture screw with a "double D" head. (Figure 1) A special $\frac{1}{4}$ " drive socket (C-91-86197) is available for adjusting this screw.

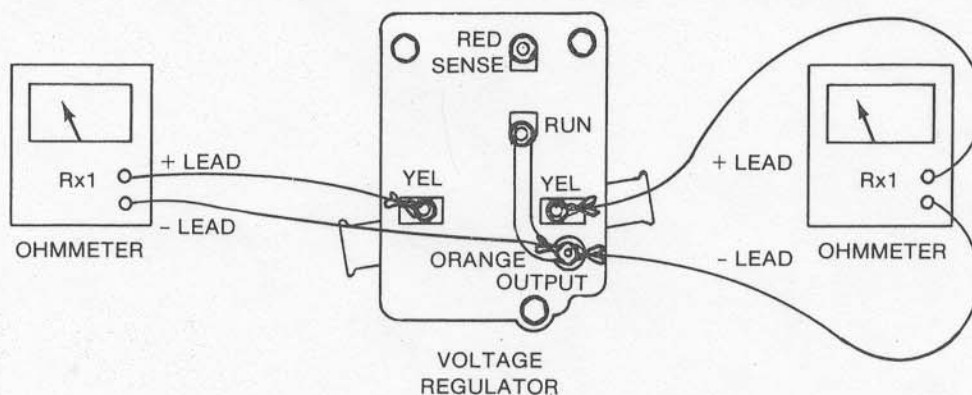
Figure 1. Checking Regulator Diodes

Check regulator diodes (Figure 1) by connecting positive (+) ohmmeter lead to one stator terminal (yellow) and negative (-) ohmmeter lead to output (orange) terminal. Meter MUST show conduction. Reverse ohmmeter leads. Meter MUST NOT show conduction. Repeat test for other stator (yellow) terminal.

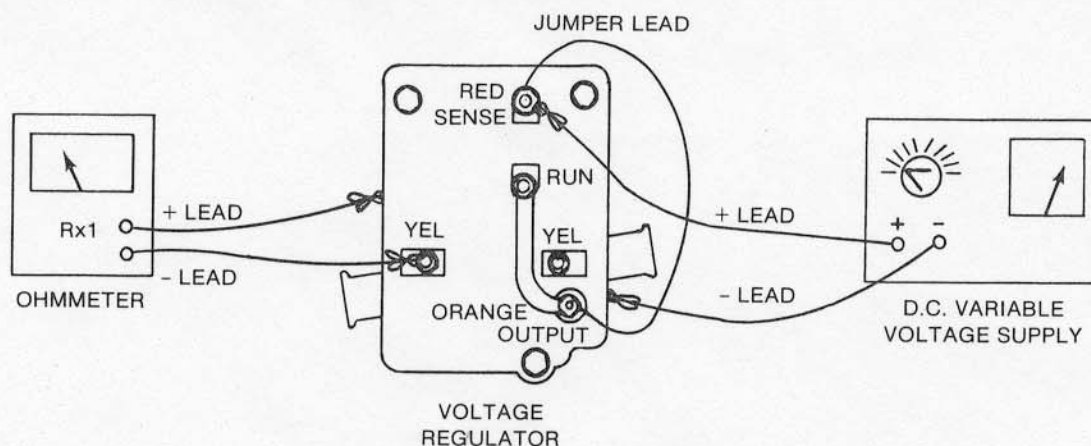
Figure 2. Checking Voltage Regulator Point - Water Cooled Regulator

Check voltage regulation point using a D.C. variable voltage supply and ohmmeter (Figure 2). Connect voltage supply positive (+) lead to sense (red) terminal. Connect jumper wire from sense (red) terminal to output (orange) terminal. Connect voltage supply negative (-) lead to ground on regulator case. Turn on voltage supply to 16-18 volts. Connect ohmmeter positive (+) lead to ground on regulator case and ohmmeter negative (-) lead to one stator (yellow) terminal. Ohmmeter MUST NOT show conduction. If meter shows conduction, momentarily disconnect and reconnect it. If meter still shows conduction, voltage regulator is bad (regulation point too high) and must be replaced. If meter did not show conduction, slowly reduce voltage supply setting while observing ohmmeter. Meter MUST go into conduction at some voltage between 15 volts and 13.5 volts. If meter does not show conduction when supply voltage is reduced to between 15 volts and 13.5 volts, voltage regulator is bad (regulation point too low) and must be replaced. Repeat test for other stator (yellow) terminal.

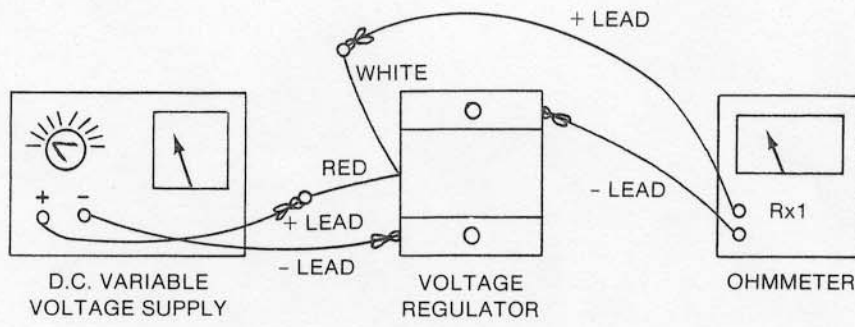
Figure 3. Checking Voltage Regulation Point - Air Cooled Regulator

2. Check voltage regulation point using a D.C. variable voltage supply and ohmmeter (Figure 3). Connect voltage supply positive (+) lead to regulator red lead and voltage supply negative (-) lead to ground on regulator case. Connect ohmmeter positive (+) lead to regulator white lead and ohmmeter negative (-) lead to ground on regulator case. Slowly increase voltage while observing ohmmeter. Meter must show conduction when voltage reaches 14.5 volts ($\pm 0.5v$). If meter shows conduction before voltage reaches 14 volts, regulation point is too low and voltage regulator must be replaced. If meter does not show conduction until voltage exceeds 15 volts, regulation point is too high and voltage regulator must be replaced.

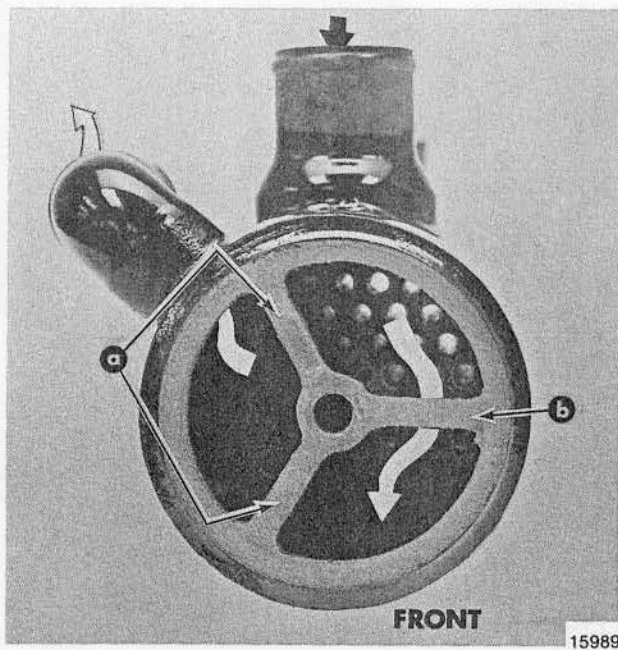
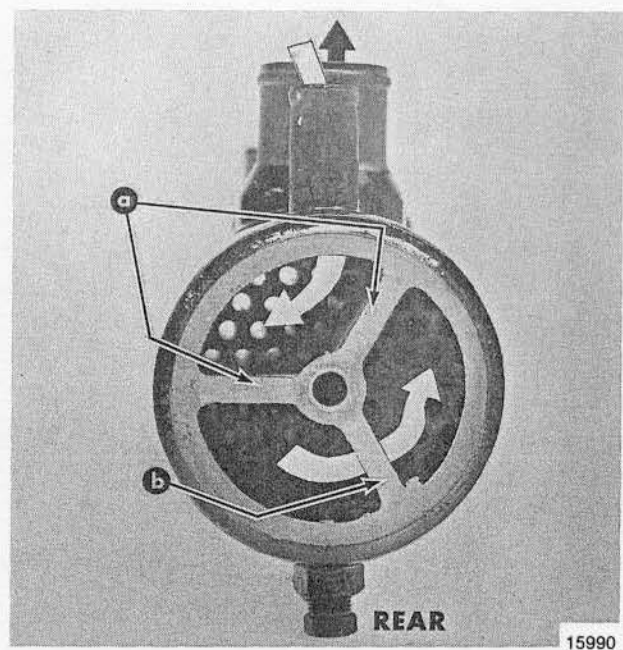
Figure 5. 75959 End Casting Placement [MCM 470 3" (8cm) Dia.]

- a. Freezing the seawater circuit usually forces the end castings out of the shell. These castings can be cleaned, re-inserted properly and soldered in place by a radiator shop. Refer to Figures 5, 6, 7 or 8 for proper placement of end castings.

IMPORTANT: The end castings directs the seawater flow through the heat exchanger in Stern Drive (MCM) Engines. If they aren't installed correctly, the water takes a short cut and two-thirds (or more) of the exchanger is not used.

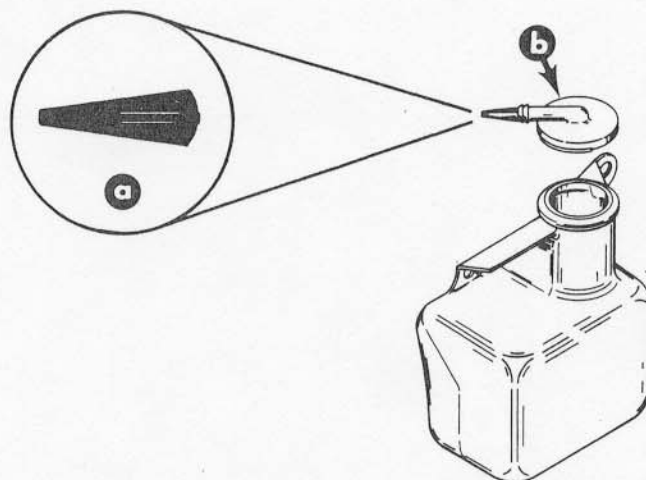
Figure 1. Remove and Discard Plug

Early production runs of the above model engines had this "plug" in the air vent of the Coolant Recovery Bottle Cap. If this plug is not removed, engine may overheat. Remove and discard "plug" from all the above model engines before running engine. Later production engines do not have this "plug" installed.

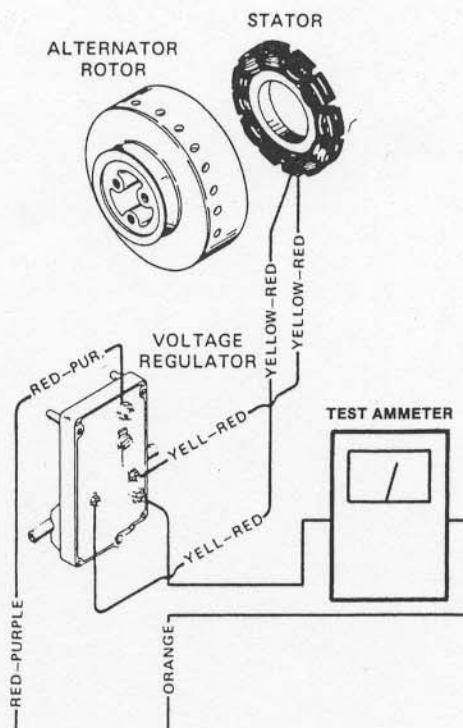
CONSTANT HIGH OUTPUT

1. Remove one yellow-red wire from its regulator terminal and tape back temporarily. Run engine at 1000 RPM. Any output current indicates a stator short to ground.
2. Reconnect the yellow-red lead and repeat test with the other yellow-red lead.
3. If there is no output with either yellow-red lead in the above test, the regulator is bad.

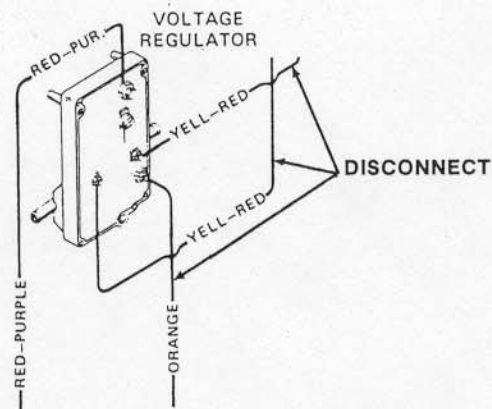
NO OUTPUT

1. Remove the 2 yellow and the orange leads from the regulator.
2. Check the resistance between the regulator case and either yellow/red stud. A near zero reading from either stud to the case - replace regulator.

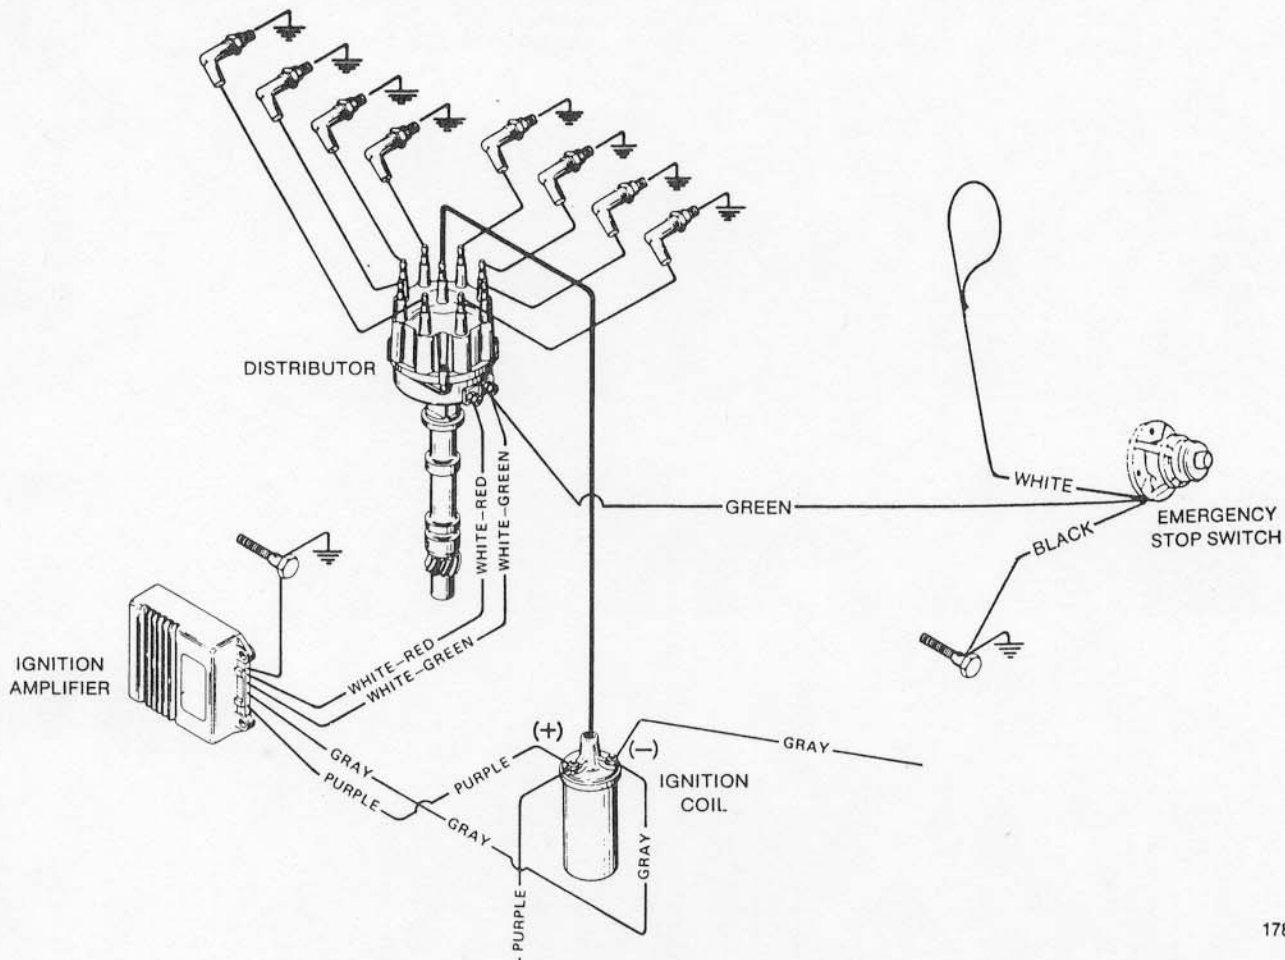
G. EMERGENCY STOP SWITCH (65503A2) WIRE CONNECTION - THUNDERBOLT IV (HEI) IGNITION SYSTEMS

1. Tape white stop switch harness lead to harness and insulate with at least two layers of electrical tape.
2. Connect green stop switch harness lead to distributor terminal which has white-green lead already connected to it.
3. Connect black stop switch harness lead to convenient engine ground.
4. Coat connections with Liquid Neoprene.

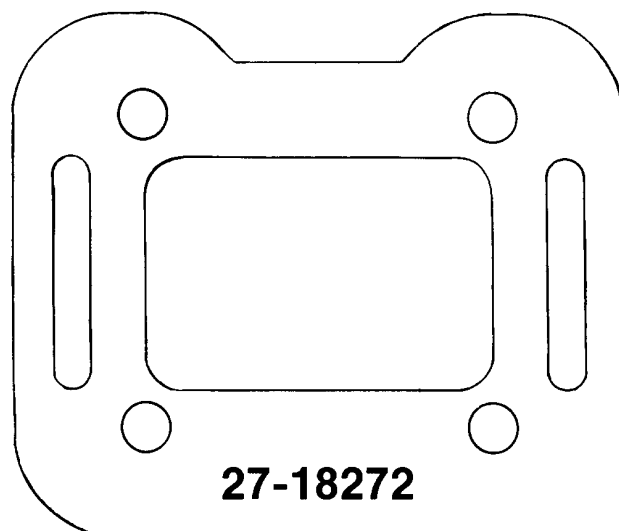
Figure 1.

There has been a few reports on the MerCruiser 224 CID 3.7 litre engines with aluminum exhaust manifolds having a piston knock caused by a tight piston pin. The starting serial numbers of engines with aluminum exhaust manifolds are 165/170 3.7L A528109 and up, 180/190 3.7 L/LX A528516 and up. The tight pin may be caused by engine coolant entering the cylinders because of a leaking exhaust elbow/reservoir to exhaust manifold gasket part number 27-97863. The early style 27-97863 gasket had a silicon seal on both sides. The later style 27-97863 gasket was changed to a graphite type (Figure 1). 27-97863 is now superseded to 27-18272 which is a graphoil/tin composite (Figure 1). Starting serial numbers of production engines, with the 27-18272 gaskets are 165 3.7L B742442 and up 180 3.7L/LX B743204 and up. Gasket part number 27-18272 is also in Quicksilver parts stock.

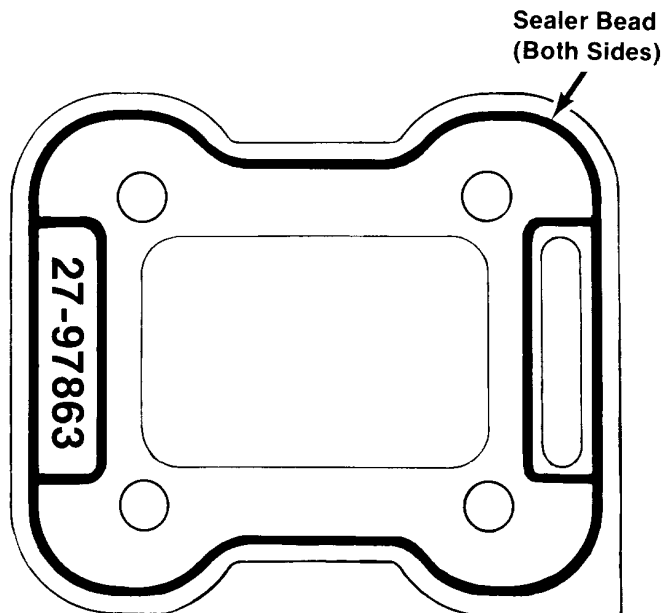
Figure 1.

There has been a few reports on the MerCruiser 224 CID 3.7 litre engines with aluminum exhaust manifolds having a piston knock caused by a tight piston pin. The starting serial numbers of engines with aluminum exhaust manifolds are 165/170 3.7L A528109 and up, 180/190 3.7 L/LX A528516 and up. The tight pin may be caused by engine coolant entering the cylinders because of a leaking exhaust elbow/reservoir to exhaust manifold gasket part number 27-97863. The early style 27-97863 gasket had a silicon seal on both sides. The later style 27-97863 gasket was changed to a graphite type (Figure 1). 27-97863 is now superseded to 27-18272 which is a graphoil/tin composite (Figure 1). Starting serial numbers of production engines, with the 27-18272 gaskets are 165 3.7L B742442 and up 180 3.7L/LX B743204 and up. Gasket part number 27-18272 is also in Quicksilver parts stock.

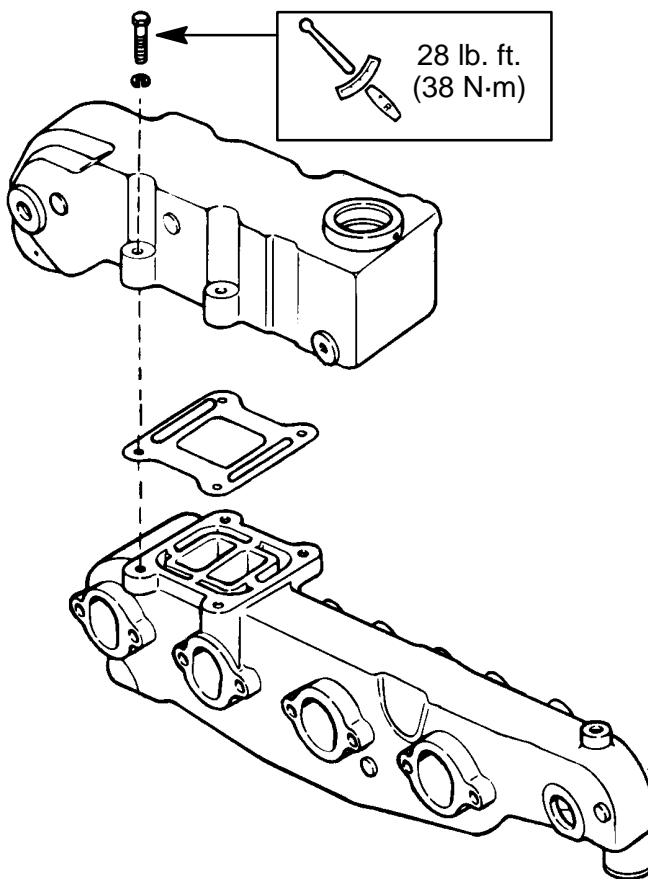
This is just a reminder to retorque the 4 bolts that hold the exhaust elbow/reservoir to the manifold anytime the elbow/reservoir is removed and reinstalled.

1. Torque 4 bolts to 28 lb. ft. (38 N·m).
2. Start engine and bring up to operating temperature.
3. After engine has cooled down, retorque 4 bolts to 28 lb. ft. (38 N·m).
